The Destructive Extent  
of the California Earth-  
quake. Its Effect Upon  
Structures and Structural  
Materials Within the  
Earthquake Belt.

By Charles Derleth, Jr.

Associate Professor of Structural  
Engineering, University of California

1907

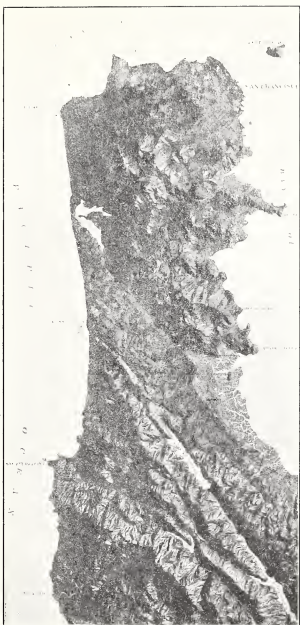
FIG. 1.—Relief Map of San Francisco Peninsula, by Professor Andrew C. Lawson; Consult Fifteenth Annual Report, U. S. Geological Survey, Page 405.

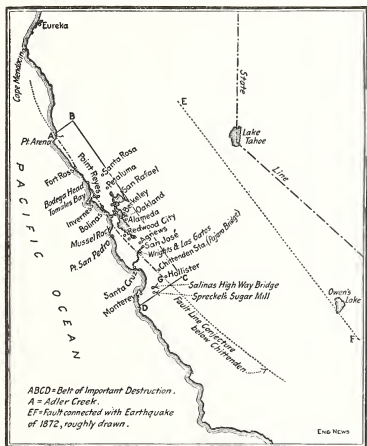
main coast range fault. This fault or rift, Fig. 2, runs in an almost exact right line from Point Arena in the north, following along the coast through structural valleys or bays in a south-south-easterly direction, to Hollister in the south. Above Point Arena it disappears into the ocean, although there is some evidence that it curves to the east and approaches the land in the region of Cape Mendocino. This is probably the case; at any rate it would explain the considerable shock felt in Humboldt County. To the south of Hollister the fault may be traced by the observing eye along the western side of the San Joaquin Valley and into the desert lands to the south; some say almost to the head of the Gulf of California. As to the exact location and limit to the fault line in the south I can not speak definitely. I have not examined that region nor does the question of southerly extent really concern the engineer in this present earthquake problem. I have followed the rift from Point Arena to the region of Hollister and Tres Pinos. In this length of a little more than 200 miles the ground along the fault line was broken, and considerable horizontal and some vertical movement occurred throughout that distance. Movement and faulting below Hollister, if there was any, was slight, and I have heard of no authentic reports. Below Hollister, moreover, there is little improved

FIG. 2—Map of California, Showing Position of Fault Line, Earthquake of 1906. Reprinted from "Engineering News," June 28, 1906.

property and therefore hardly anything of engineering importance to destroy. Along the fault from Point Arena to Hollister the earthquake destruction was most severe. Water pipes, conduits, bridges, fences, roads, water courses, all things that crossed the line were crippled or rent asunder. In the north, trees were uprooted, broken and cracked, and everywhere along the fault buildings of weak construction were violently thrown down.
